Mock Inspection Report

4819 South 6th Street, Louisville, KY, USA

Mar 11, 2025

Performed by David Smith

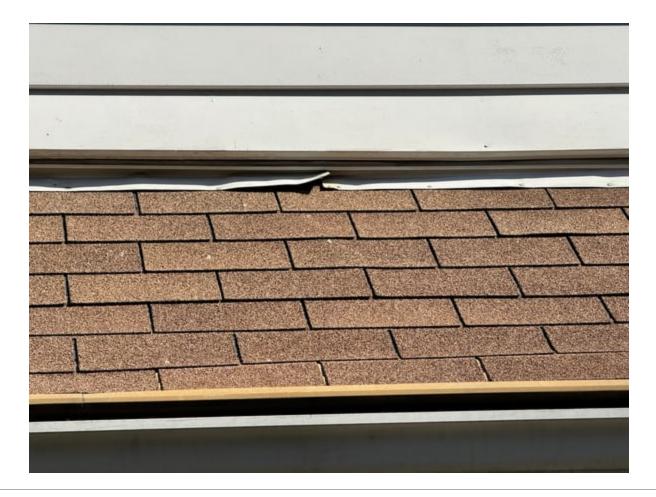
Vents, Flashing, Skylights, Chimney, and Other Roof Penetrations

Minor Defect

Flashing is popped up and needs to be nailed down by a quilfied roofing contractor.

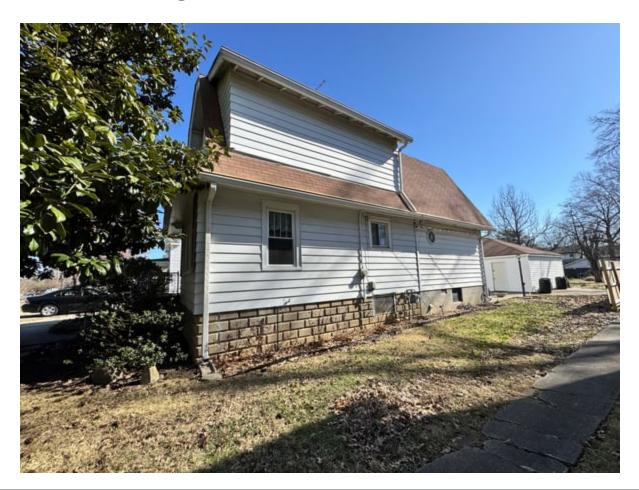
Vegetation, Surface Drainage, Retaining Walls and Grading of the Property (where they may adversely affect the structure due to moisture intrusion)

Cosmetic Defect

Recommend trimming tree back from house.

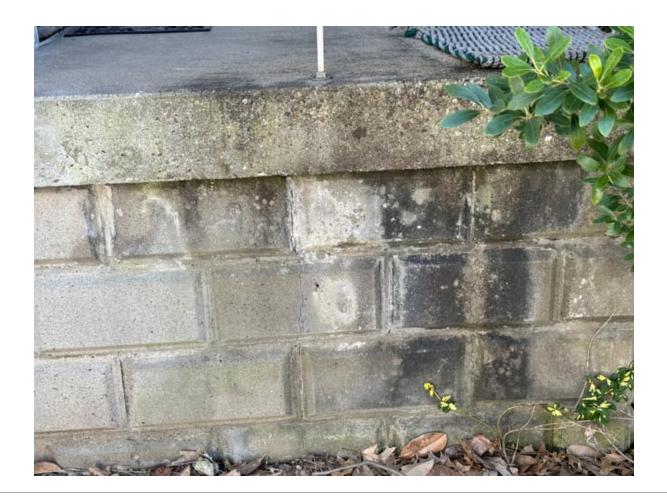
Foundation

Cosmetic Defect

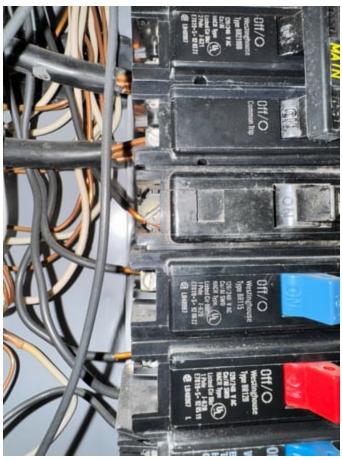
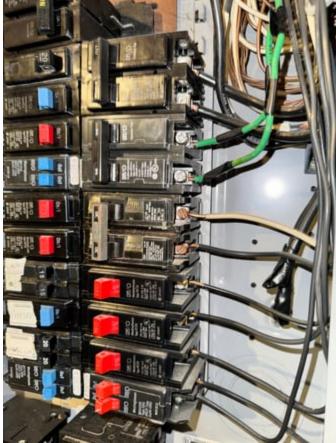
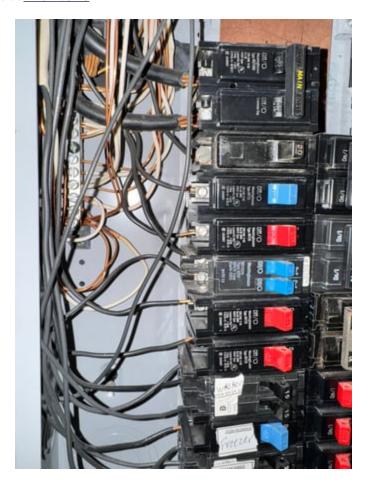
Panelboards and Over-Current Protection Devices (circuit breakers and fuses)

Minor Defect

One or more conductors with the insulation stripped back to far. Recommend that its corrected by a licenced bonded electrical contractor.
